TO: Minerals File  
FROM: Paul Baker, Reclamation Biologist *PBB*  
RE: Site Inspection, ECDC Environmental, LC, ECDC Clay Mine, M/015/062, Emery County, Utah

Date of Inspection: September 6, 2001  
Time of Inspection: 5:00 to 6:00 p.m.  
Participants: Tony Gallegos and Paul Baker, DOGM

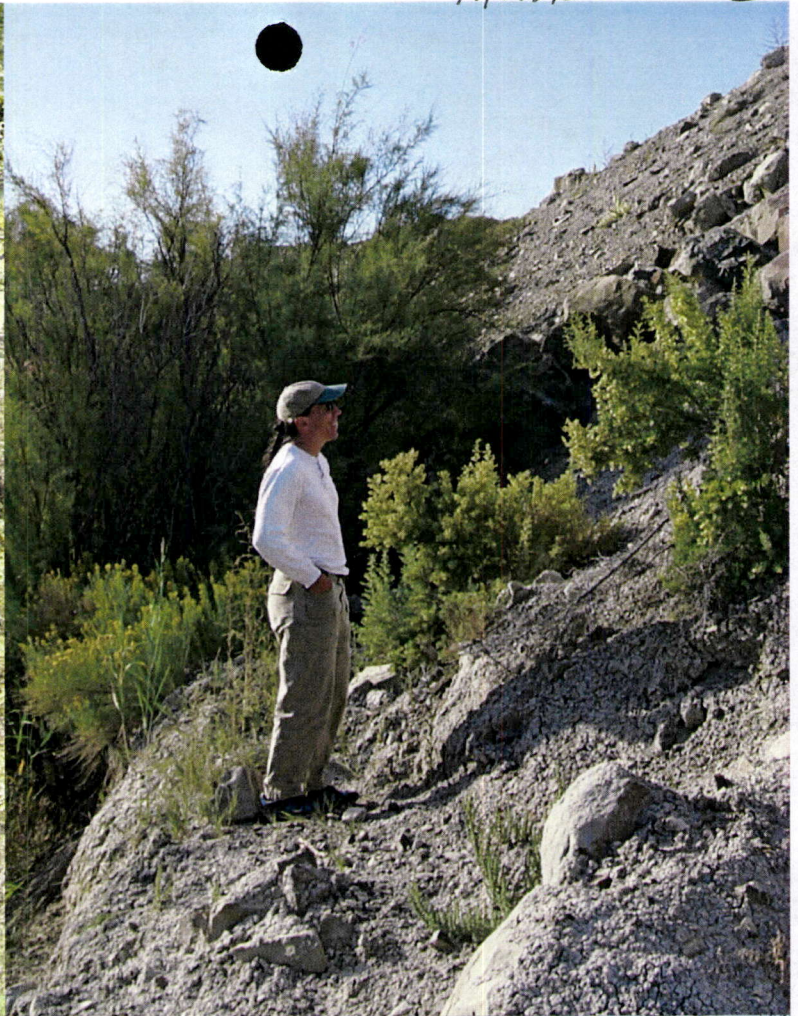
Photos of the site are attached to this report. The photos labeled 2 and 7 are overviews of the area. In photo 2, the pile in the center left is the area presumed to be a spoil or waste pile. In the foreground is an area with a low or non-existent berm. Photos 1, 3, 5, and 8 show where we found remnants of a straw bale dike. The other pictures are intended to show the proximity of the disturbance to the Price River.
